# Managers & Supervisors Legal Safety Responsibilities

Understanding California  
OSHA & IIPP Requirements

# CCWD Incidents Last 18 Months

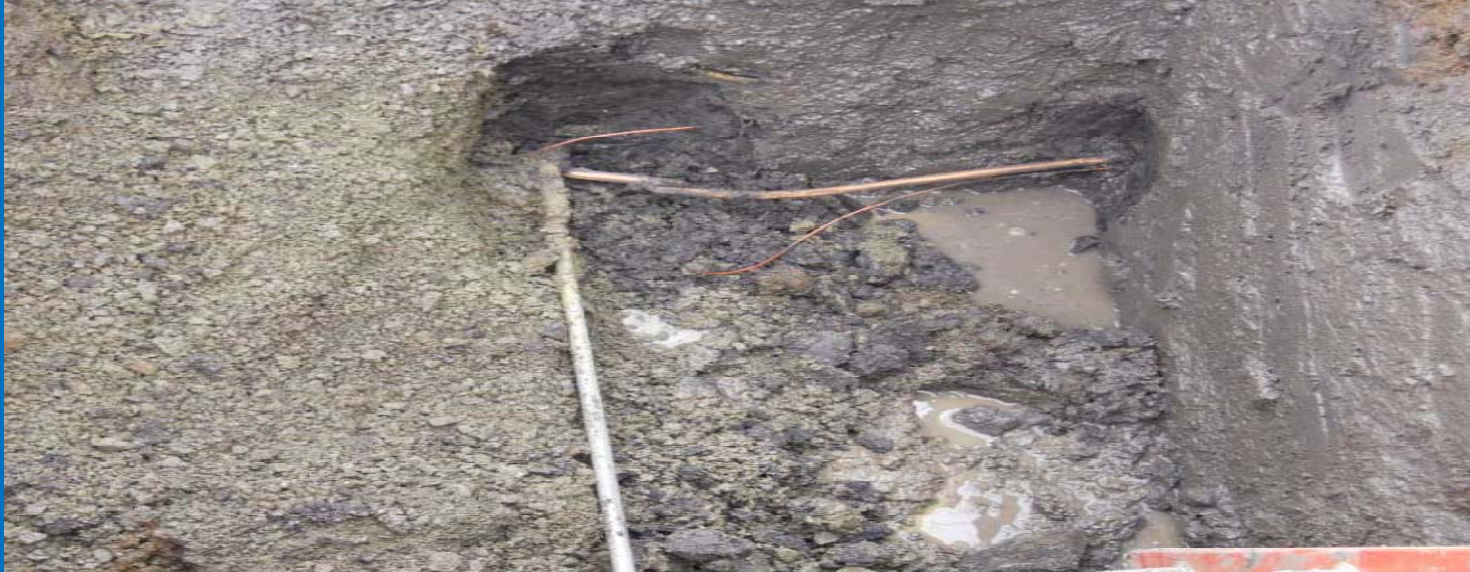
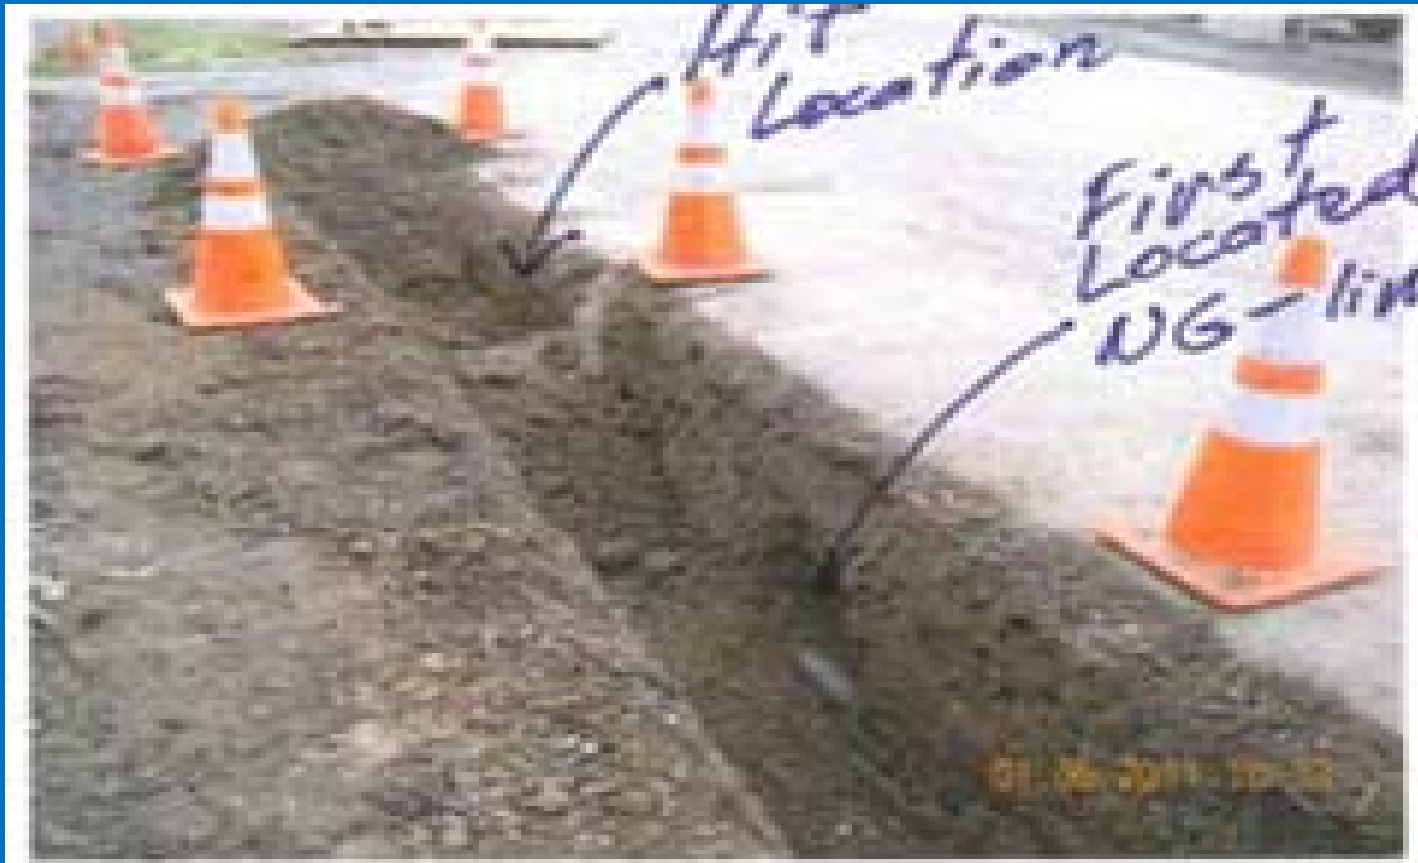
## 3/15/11 Sun Valley Gas Line Incident

- The crew then set up traffic control, began jack hammering, and began excavation with backhoe.
- Hand digging was performed within 2' of gas marks.
- The crew followed the policy of probing 12 inches or more and mechanically digging 6 inches.
- The backhoe bucket hit gas service at 3' deep and 29" away from the PG&E yellow gas service marks.
- The crew leader blocked the street on both ends and notified the affected houses.
- PG&E incorrectly marked the gas line by 29" and mistakenly located the parallel abandoned copper line which was approximately 30" west of the active plastic line.
- District crews attempted to locate the gas service with a metal detector but it did not pick up the copper trace line.
- The locating wand (Cable Locater) also did not work as there was no electrical current to detect in the copper locate wire on the gas

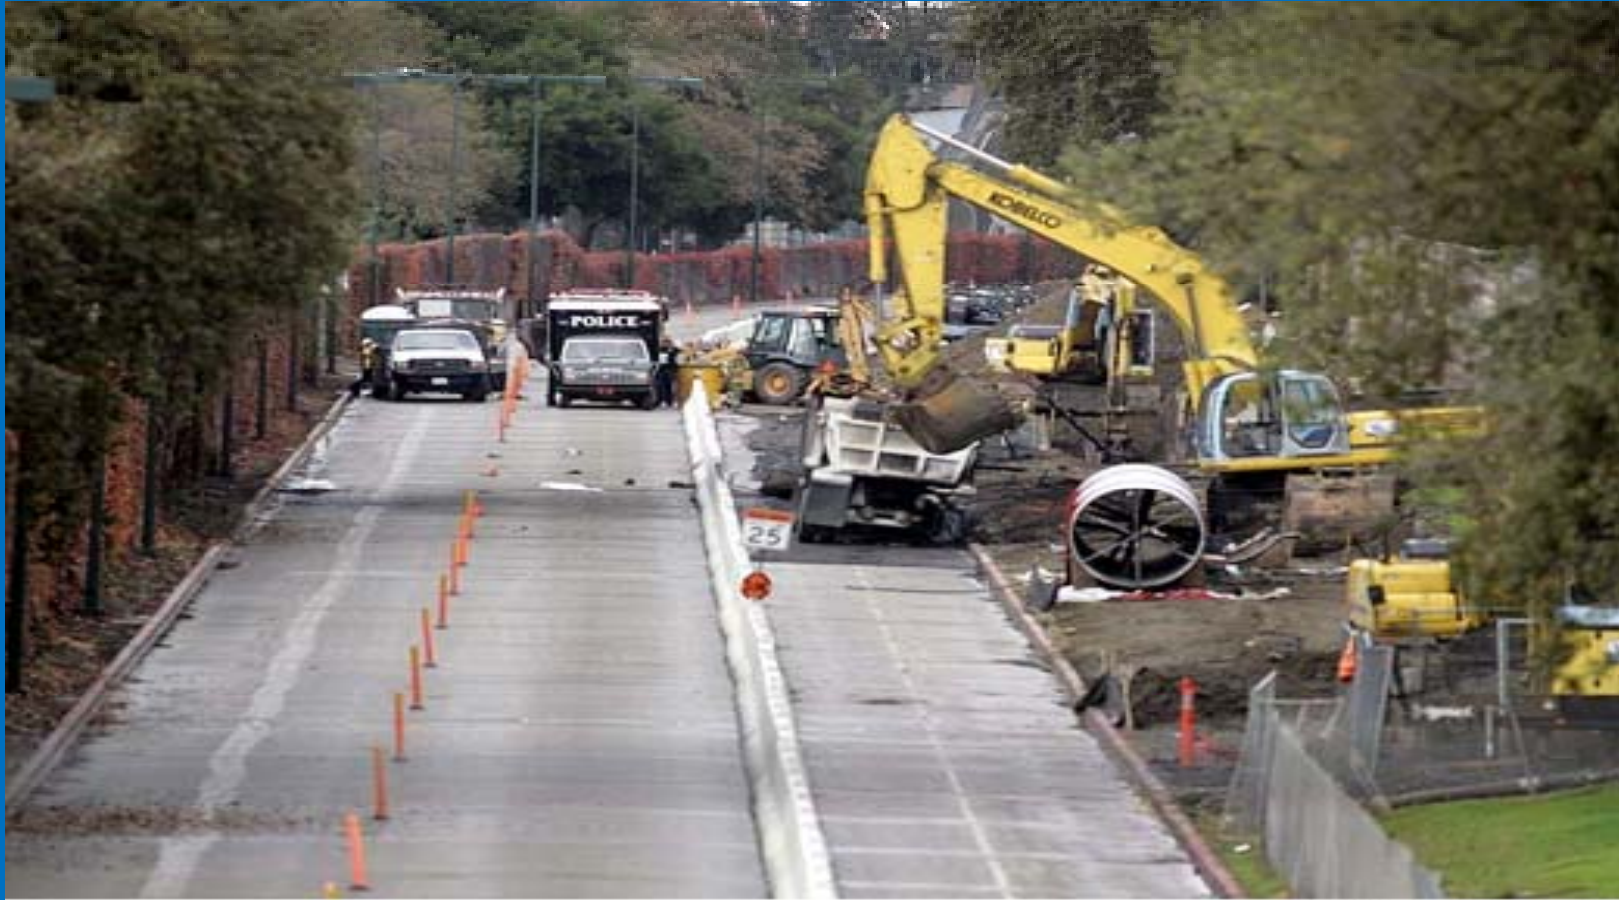
## Incident Review #4

1/6/11. During a new main installation project off Pacheco Blvd, the Heavy Crew struck and ruptured a 2 inch gas main during excavation activities. The gas main was marked, and the crew had probed, located and excavated the gas main about 10 feet away from the rupture point. However, old road pavement had made it impossible to probe further. The crew decided to use a backhoe to scrape away the pavement, but the gas main was located just underneath the pavement at an unexpected and shallower depth. The crew was installing the new main using preliminary designs issued from Engineering with an understanding they were being used for construction.

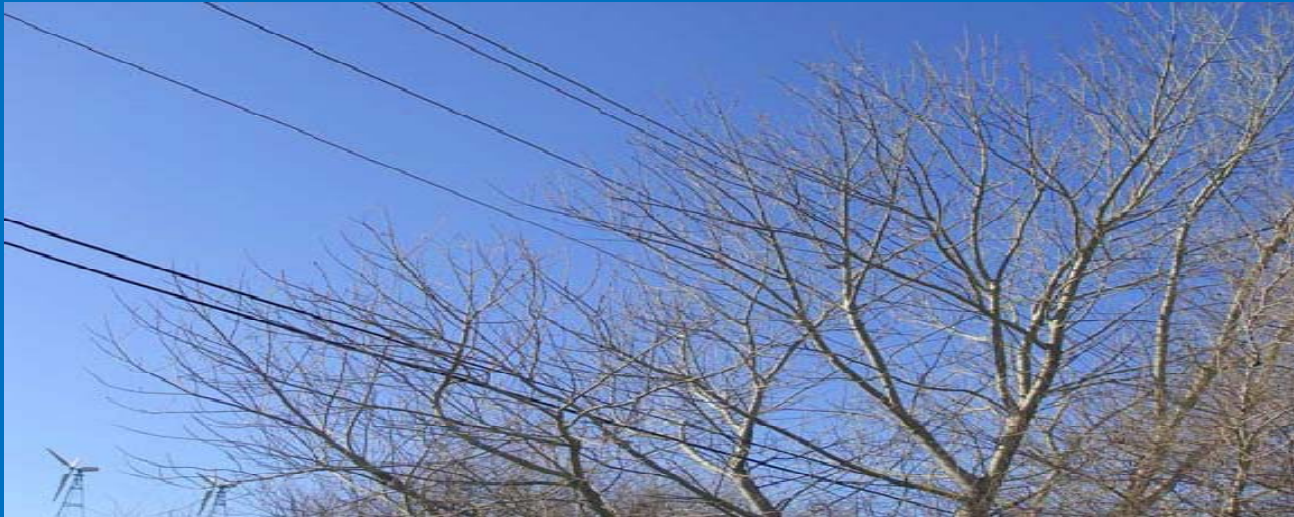
## 1/19/2011 Tree Trimming Incident

- An employee was asked by his supervisor to trim a tree. The employee declined and stated that it was dangerous to trim branches that were touching high voltage power lines. The employee told his supervisor to contact PG&E.

- Several weeks later, the supervisor asked two other employees to trim the very same tree. The employees prepared for the task and visited the job site with the supervisor. When the employees saw that four high voltage power lines were touching the tree, they said that they declined to trim the branches that contacted the power lines and told the supervisor to contact PG&E. The two employees instead trimmed lower branches from another tree hanging that were not contacting the lines.

- The supervisor said that he had not asked any staff to trim the branches touching the power lines
- The supervisor also said that he did not initially notice that the power lines were contacting the tree and that they recently became overgrown. The supervisor contacted the owners of the power lines to trim the tree
